LARGE-SCALE TESTING OF A STEEL-CONCRETE COMPOSITE FLOOR SYSTEM
UNDER COLUMN LOSS SCENARIOS

THESIS

Submitted in partial fulfillment of the requirements
for the degree of Master of Science in Civil Engineering
in the Graduate College of the
University of Illinois at Urbana-Champaign, 2014

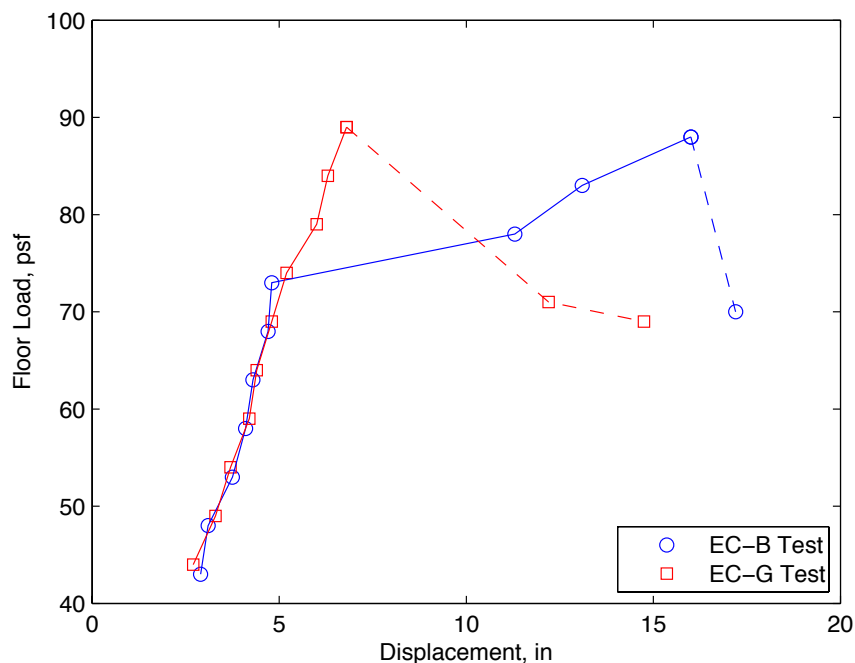
Figure 3.8 Edge Column Tests Floor Load vs. Removed Column Displacement

While both failed at essentially the same load, the EC-B test displayed more ductility. In the initial load increments before any concrete cracked, both floor sections had the same stiffness (defined based on vertical load-deflection behavior). At around 5 in. of displacement, the concrete slab cracked in the EC-B test, causing much larger subsequent displacements. The floor continued to resist load up to 83 psf (Figure 3.9a) and failed with 88 psf. (Figure 3.9b)

The final equilibrium for the EC-G floor bays was 84 psf (Figure 3.10a). The floor failed at 89 psf when the concrete slab cracked and the steel framing failed simultaneously (Figure

3.10b), as illustrated by the lack of ductility in the EC-G plot in the figure. The dashed lines in Figure 3.8 indicate the estimated post-failure reduction in floor load as the crane carried more load with increased displacement.

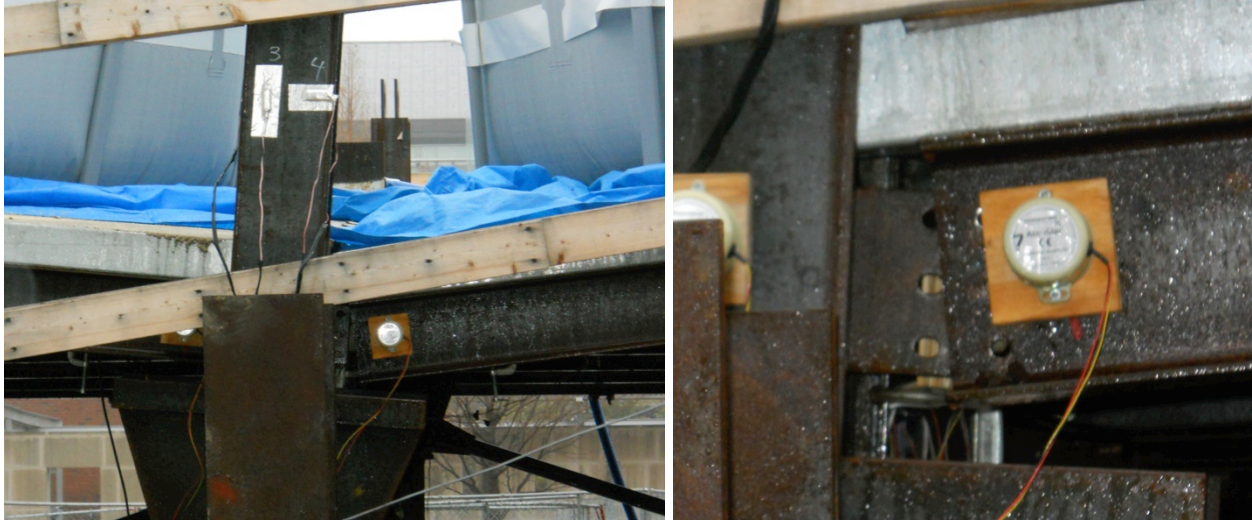
Figure 3.15 EC-B Test Removed Column Rotation at A2

The shear tab beam-to-column connections rotated more than the double-angle girder-to-column connections. At the far end of the members away from the removed column, Figure 3.14e shows the greater rotation in the beam connections. Figure 3.14f shows the same thing for the removed column connections, but also shows that most of the connection rotation in the beams was concentrated on the north beam. By late in the test, the upper section of the removed column had rotated out and to the north so that the connections remained relatively rigid except for the north beam connection. In an actual multi-story building, upper floors above the lost column would brace the intact sections of column, keeping it essentially vertical. In this test case, the lack of lateral bracing in the column left it free to rotate, causing all of the connection deformation to be in one connection. (Figure 3.15)

Figure 3.16 shows the connection extensions at the removed column (a) and the far columns (b). The magnitudes of the extensions are very small for all connections except the north-beam-to-removed-column connection, which can be seen in Figure 3.15b.

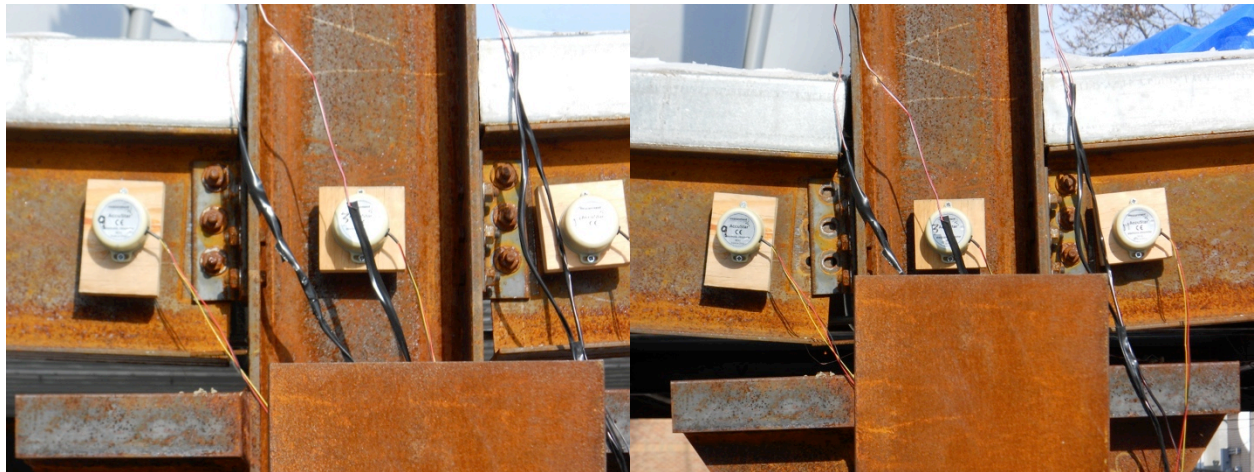
Figure 3.22 EC-G Test Removed Column Connection Deformations

The girders rotated more rigidly (Figure 3.21c and Figure 3.21d), with the removed column ends rotating slightly more. The flexural-member-to-column connections at the far ends from the removed column (Figure 3.21e) exhibited similar rotations. At the removed column (Figure 3.21f), the beam connection rotated similarly to the connection at the opposite end of the beam. The east girder connection began with greater rotation, but the west girder caught up and greatly exceeded the east girder connection rotation as the floor failed. In the photo of the final equilibrium (Figure 3.22a) the east girder connection has slightly more rotation, but it can be seen in the post-failure photo (Figure 3.22b) that it was the west girder connection that was weaker and was the first to fail from bolt shear.

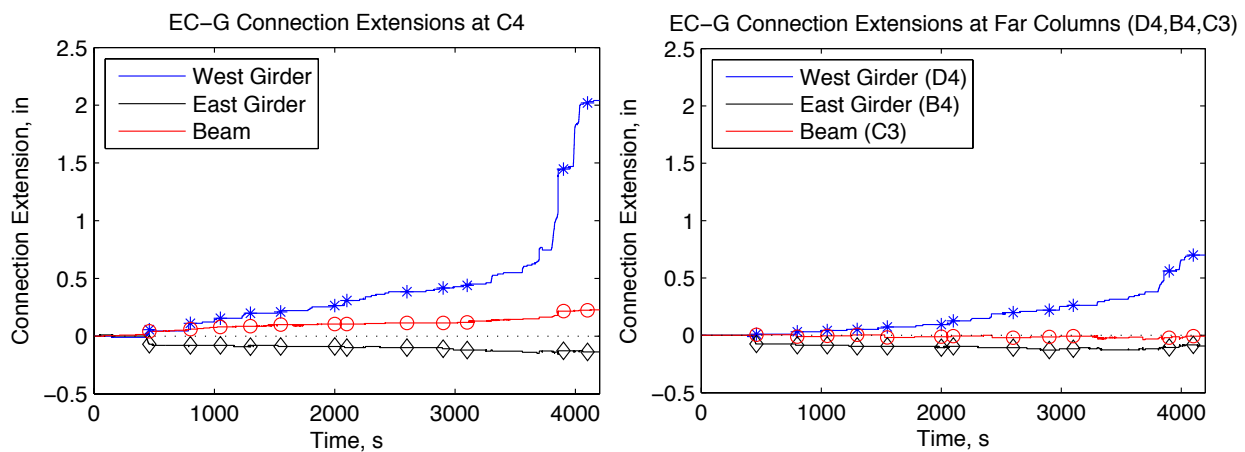
Figure 3.23 EC-G Test Connection Extensions

The connection extensions for the EC-G test show how much more even the connection deformations were here than in the EC-B test. Noting that the final equilibrium happened just before the 3000 s mark of the test, Figure 3.23 shows that for both the removed column ends (a) and far ends (b) of the girders, the connection extensions were similar. It is not until the post-failure portion of the test that the west girder connection extension increases greatly.

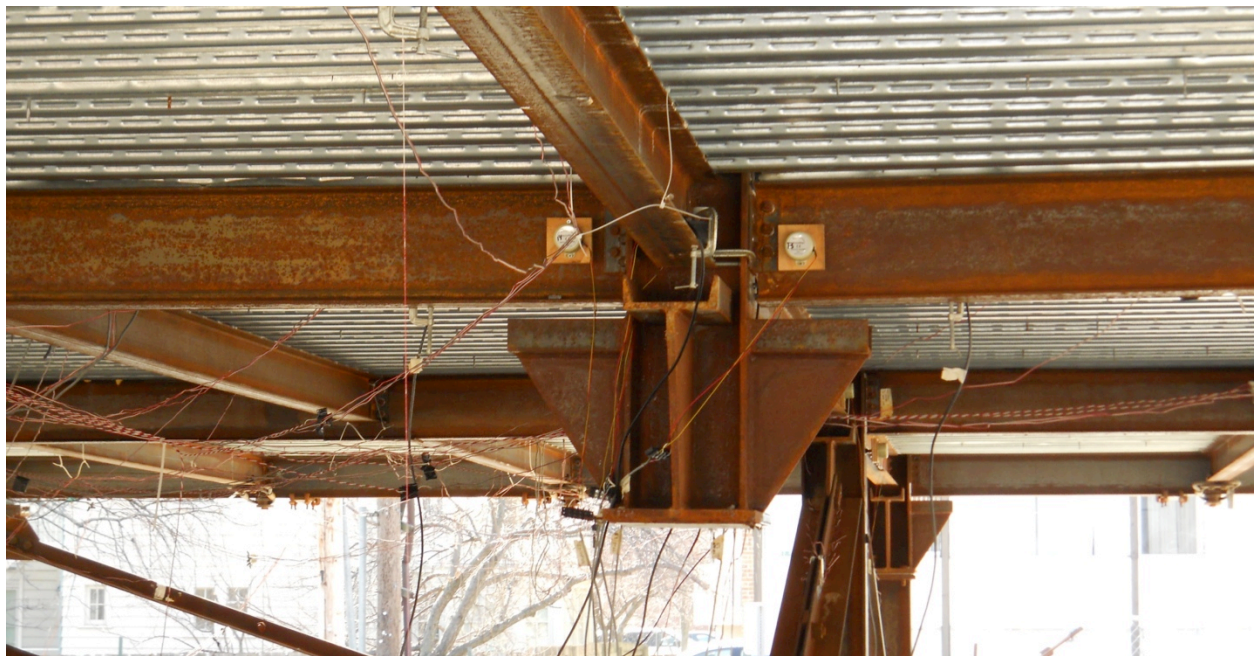
Figure 3.25 IC Test at First Equilibrium (1.5 in. Displacement, 27 psf)

The procedure for the IC test differed from the previous tests. No crane was used for the final test because the available crane could not support the floor load with the longer reach required for an interior column. To remove the column, the floor was jacked up from beneath just enough to slide out the removable column section. The jack was then slowly released until the floor was at its first equilibrium point. The floor had no water load at the time of column removal. Figure 3.25 shows the first equilibrium of the IC test with the column removed.

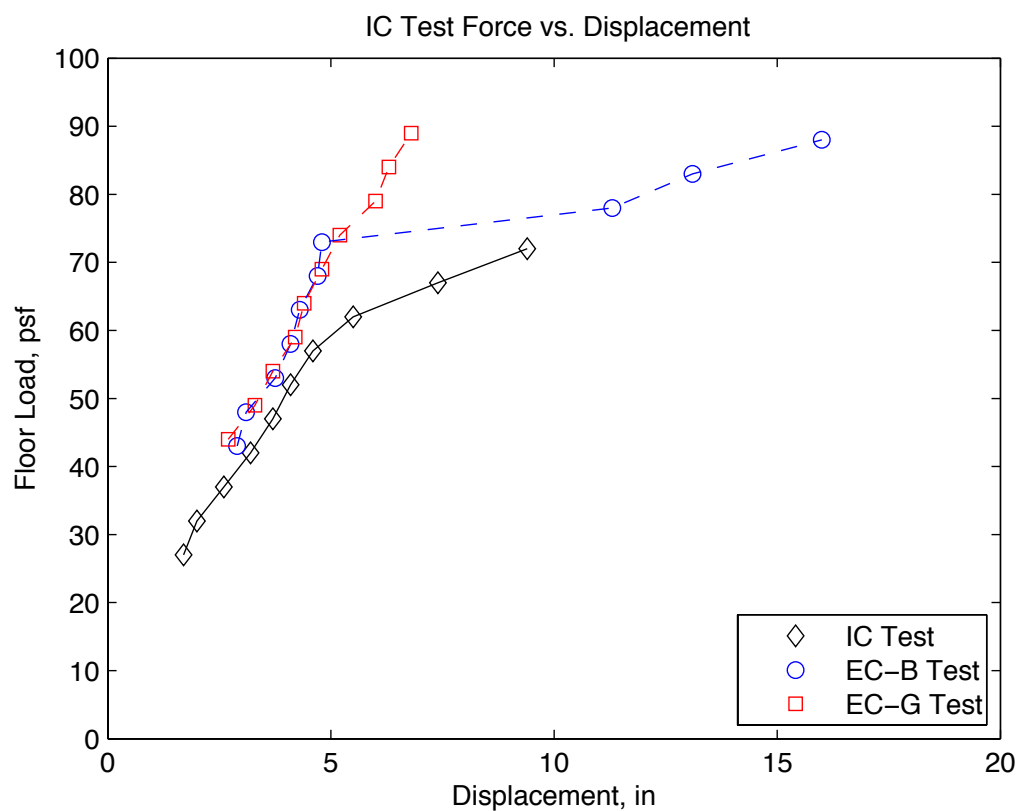
Figure 3.28 IC Test Floor Load vs. Removed Column Displacement (Edge Column Tests Shown for Reference)

The IC test was expected to have the greatest capacity of all the tests since both the girders and beams provided tie forces to support the floor. Figure 3.28 shows, however, that the maximum sustained load for the IC test was only 67 psf, much less than the nearly 85 psf sustained in the edge column tests. The IC floor collapsed within a minute of the 72 psf load increment being completed. In addition to the reduced capacity, the stiffness in the first deformation domain of the IC test, indicated by the slope of the curve in Figure 3.28, was slightly less than that of the edge column tests. It was determined that the lower strength and stiffness of the IC test was caused by damage in the concrete floor slab as a result of the previous edge column tests. A more detailed explanation is presented in section 4.1.4 .

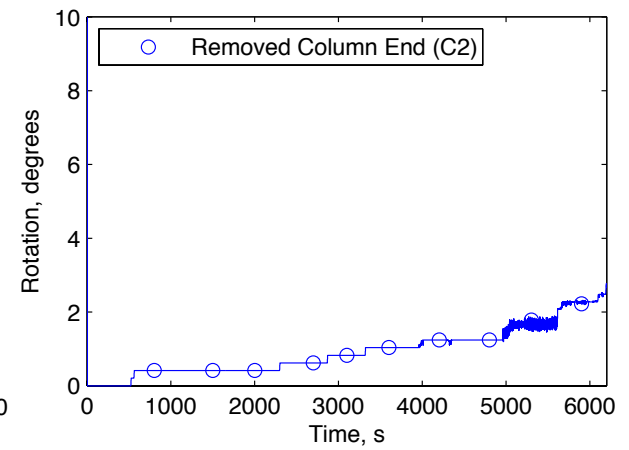
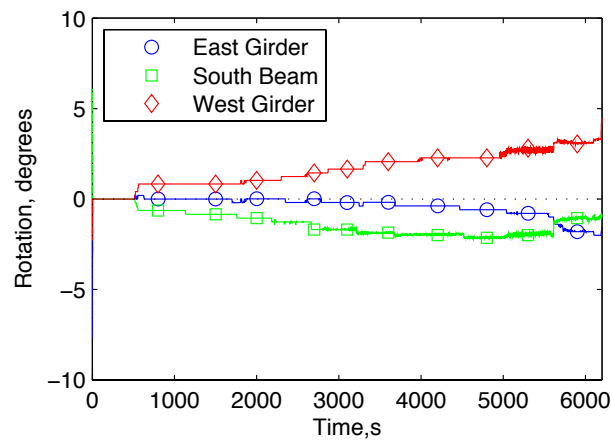
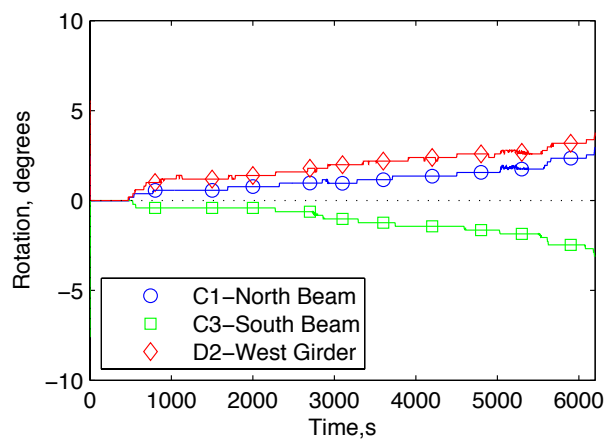
Figure 3.32 IC Test Member and Connection Rotations

Because the removed column was connected to members on four sides, the column did not rotate as much as in previous tests. Some connections deformed more than others however. At the removed column connections (Figure 3.32e), the west girder connection deformed much more than the east girder. The south beam connection was the site of the first connection failure. Its rotation increased through the test. The reduction of rotation shown in the figure at the end of the test is not logical, was not visibly observed, and is likely due to one of the inclinometers slipping on its mounting that attached it to the specimen. The north beam connection rotation is not shown because of broken instrumentation. Visual observation during the test showed that the north beam connection rotated significantly less than the south beam connection.

The connection rotations at the far ends of the members from the removed column were much more even. As shown in Figure 3.32f, the two beams rotated essentially the same. Though the east girder had poor quality data recorded, it could be seen that it had the same connection rotation as the west girder because both of the girders rotated so that the bottom flanges were bearing on the columns. (Figure 3.33)

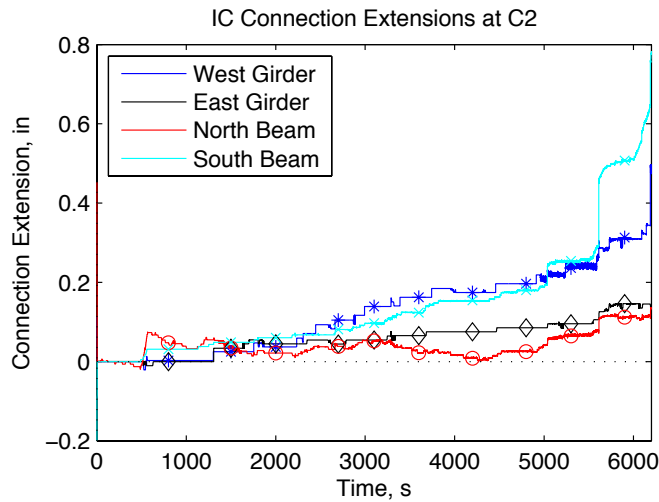
Figure 3.34 IC Test Connection Extensions at Removed Column (C2)

The connection extensions in the IC test were much smaller than in the edge column tests, mostly due to the overall floor displacement being smaller. Figure 3.34 shows the connection extensions at the removed column. The east girder and north beam had small displacements, less than 0.2 in. The south beam and west girder connections had larger extensions. These are the two connections that failed and led to floor collapse. The jump in the south beam connection extension at approximately 5600 seconds marks the failure of the bolts in that connection. The extension increases to 0.8 in. as the floor nears collapse. The west girder connection extension rises to 0.4 in and fails at 6200 seconds, the same time as the floor collapse. The connection extensions at the far columns were very small, and in some cases slightly negative. The negative values are not logical, and are likely due to the assumed center of rotation location used to estimate the extensions.

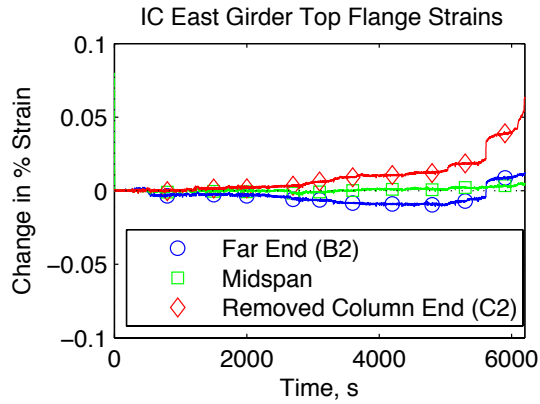
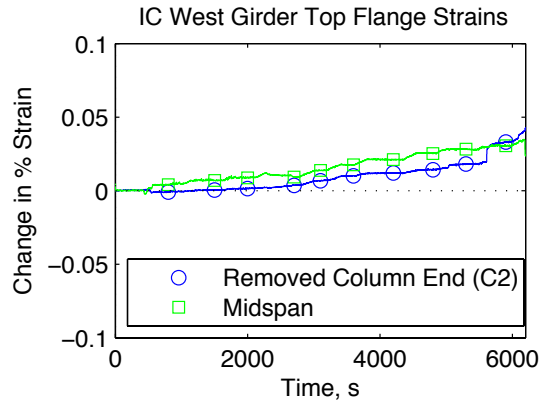
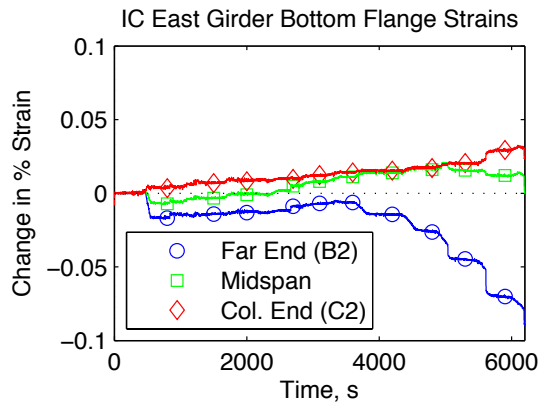
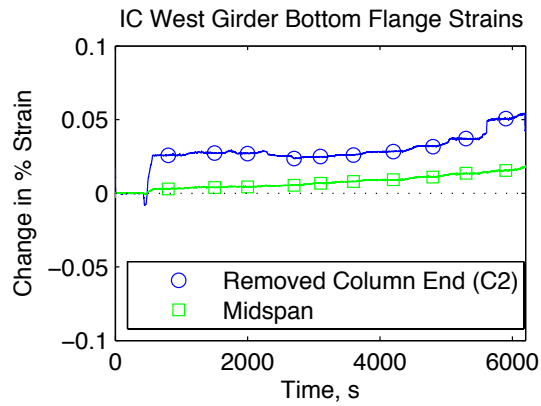
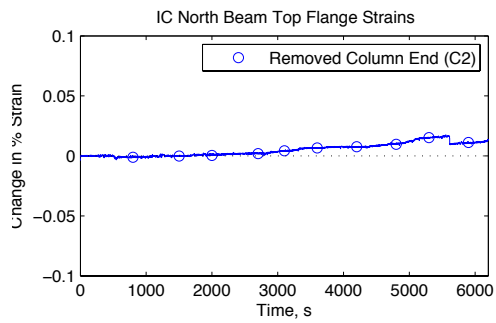
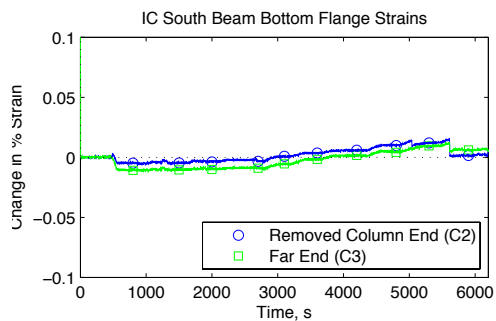
Figure 3.35 IC Test Beam and Girder Strains

Nearly every strain gauge showed tension throughout the test. The east girder (Figure 3.35a) had both flanges go into tension at the midspan and removed column end. The compression in the bottom flange at the far end of the girder developed later in the test once the bottom flange started bearing on the column. The far end gauges of the west girder (Figure 3.35b) did not collect data, but the others show tension similar to the east girder. The two beams only had three working strain gauges between them (Figure 3.35c), but putting the two together assuming similar behavior in both beams provides some insight to their behavior. The top flange at the removed column was always in tension. The bottom flange at both ends started in compression and then transitioned back to tension at the end of the test. Figure 3.35d shows the floor displacement at the removed column location for reference.

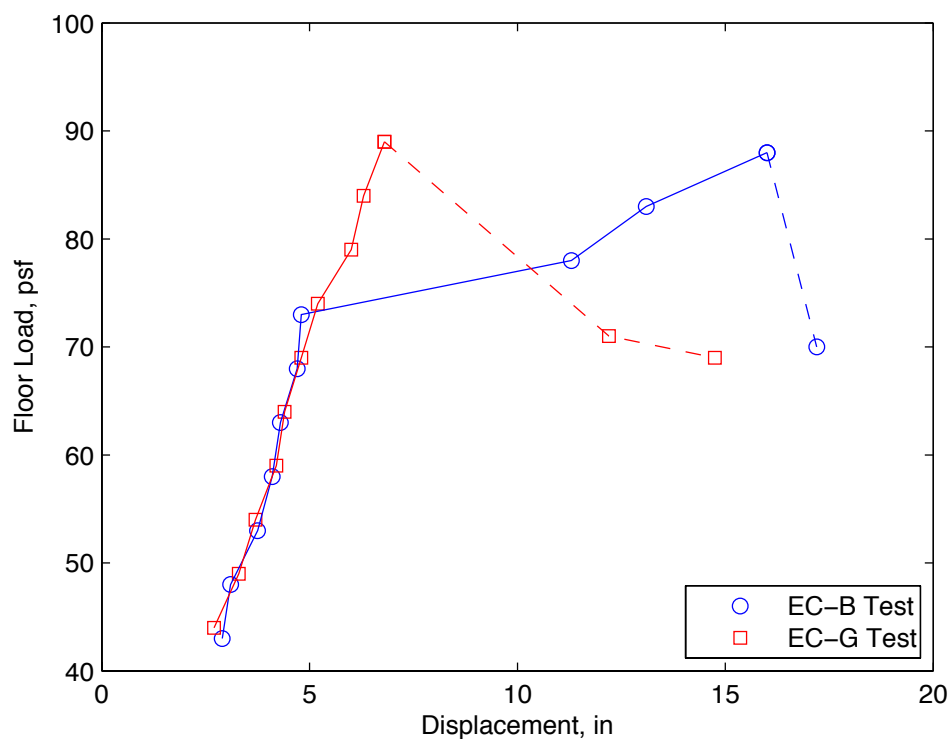
Figure 4.2 Edge Column Tests Floor Load vs. Removed Column Displacement

The EC-B test sustained appreciable deformation prior to ultimate failure. Figure 4.2 shows that two distinct domains of behavior were observed during this test. The floor began stiff, but transitioned to ductile deformation when the concrete floor slab cracked. The cracking pattern in the slab (Figure 4.3) was again at 45° angles to the bay edges. Cracks also formed along the perimeter of the loaded section where the loaded bays abutted the intact, unloaded bays.

While the EC-B test had a clear progression to failure, the EC-G test failed faster with a less clear progression. Figure 4.2 shows how the EC-G test had only one domain of deformation, keeping its stiffness to the very end. The steel connections and concrete floor slab failed simultaneously.
